NRL Memorandum Report 1950

AD 633 633 633
**Analysis of the Failure of the
AUTEC TOTO II Deep Sea Moor and the
Performance of its Cathodic Protection System**

R. E. GROOVER

November 1968

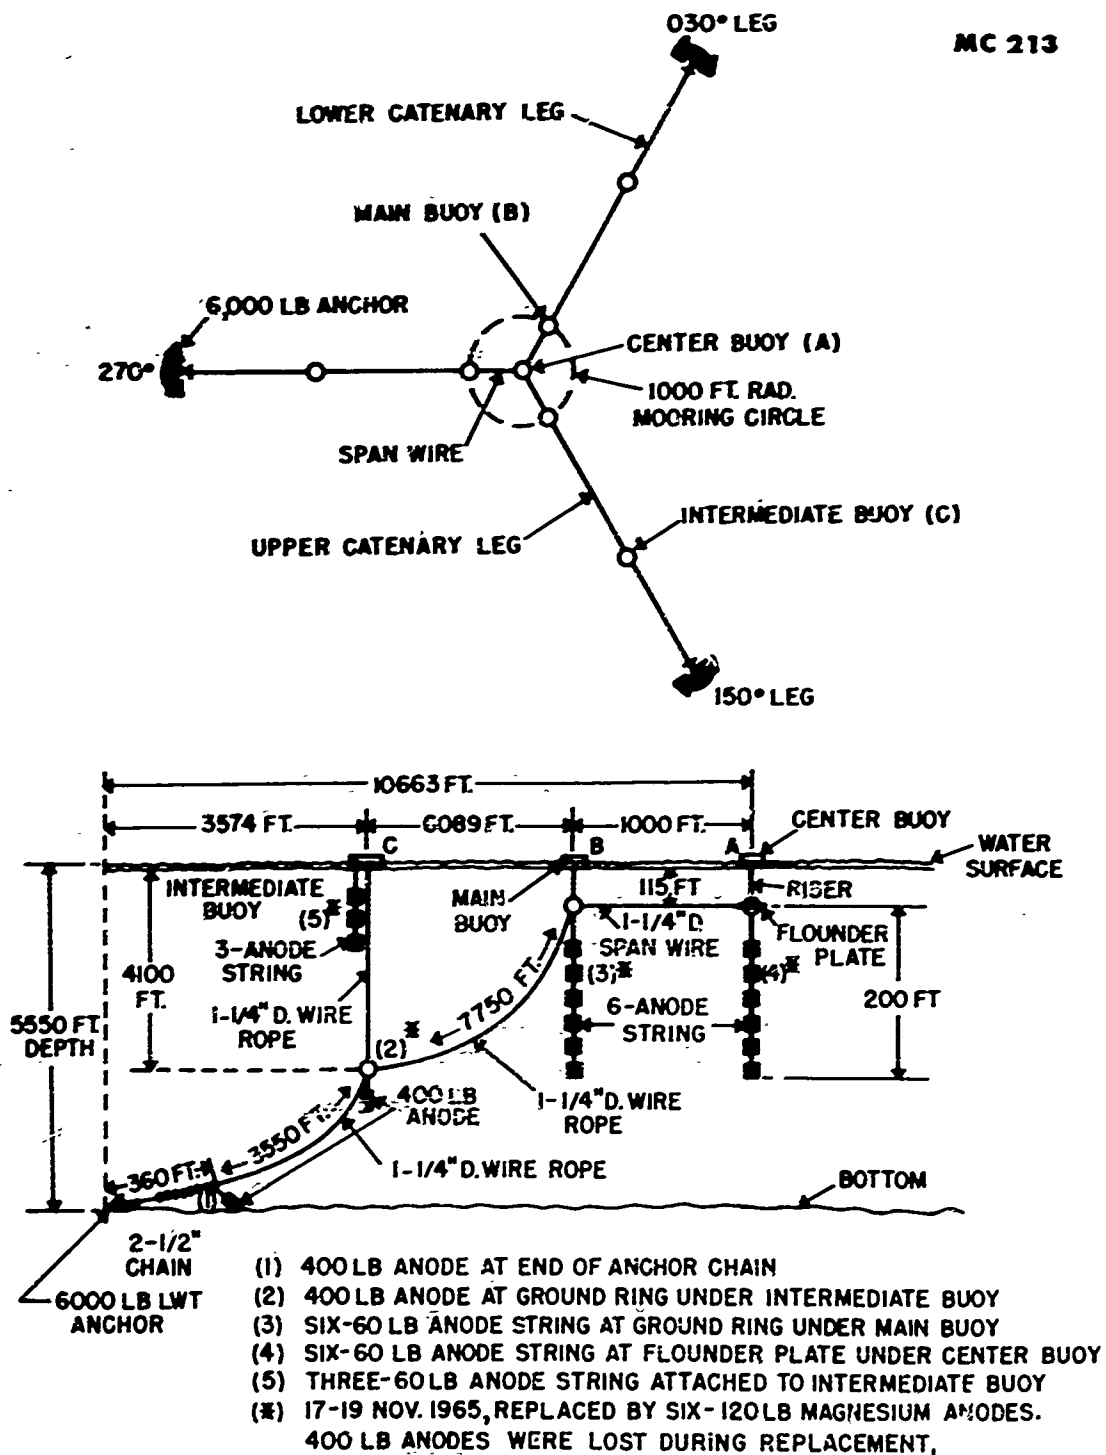
A three-point moor, designated AUTECH TOTO II, was designed by the Bureau of Ships (now Naval Ship Systems Command) to meet the set requirements (1). The moor consisted of three legs positioned 120° apart. Each leg was comprised of the center buoy, a main buoy, and an intermediate buoy. Approximately 11,000 ft of 1 1/4-in. 6x19 filler wire (WSC), extra improved plow steel, galvanized, bituminous coated wire rope connected each main buoy to an anchor chain and anchor positioned on the sea floor. A 4,100-ft vertical riser beneath each intermediate buoy supported the wire rope between the main buoy and the anchor to form an upper and lower catenary. The risers were also 1 1/4-in.-diam wire rope except the upper 105 ft of each which consisted of 30 ft of 2 1/2-in. chain and 75 ft of 1 5/8-in.-diam wire rope. A schematic diagram showing the moor and a typical anchor leg is shown in Fig. 1.

On 26-30 May 1962, the moor was laid in about 5400 ft of water in the TOTO. The late Mr. L. J. Waldron of NRL supervised the attachment of approximately 4400 lb of magnesium anodes to the moor at the locations shown in Fig. 1.

Fig. 1 - Plan view of the moor in the upper sketch and a typical mooring leg elevation in the lower sketch (not to scale).

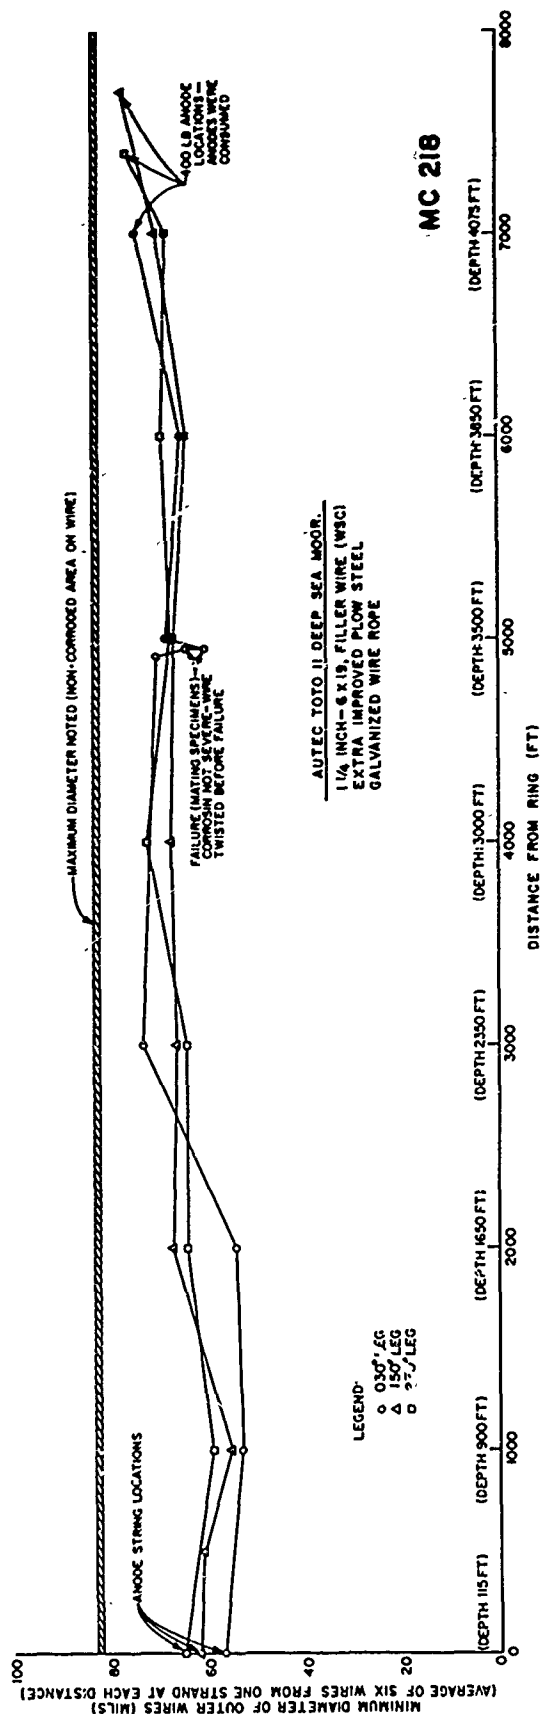
Figure 5 shows that the average minimum diameter of outer wires from the upper catenaries ranged from 53 to 77 mil. The wires having smaller residual diameters were located about 1000 ft from the upper anodes, and those having larger residual diameters were at the lower ends of the catenaries near the 400-lb anode connections. The 030° leg upper catenary twisted and failed at the location shown in the figure. It is apparent that the point of failure was not associated with minimum wire diameter or the point of highest natural stress since both would be towards the upper end of the catenary. The appearance of failed ends of wires from the 030° leg upper catenary is shown in Fig. 6.

Fig. 5 - Minimum diameter of outer wires from the upper catenaries. Distances are relative to the ring located 115 ft below each main buoy as zero. Approximate depths of water are shown in parentheses.

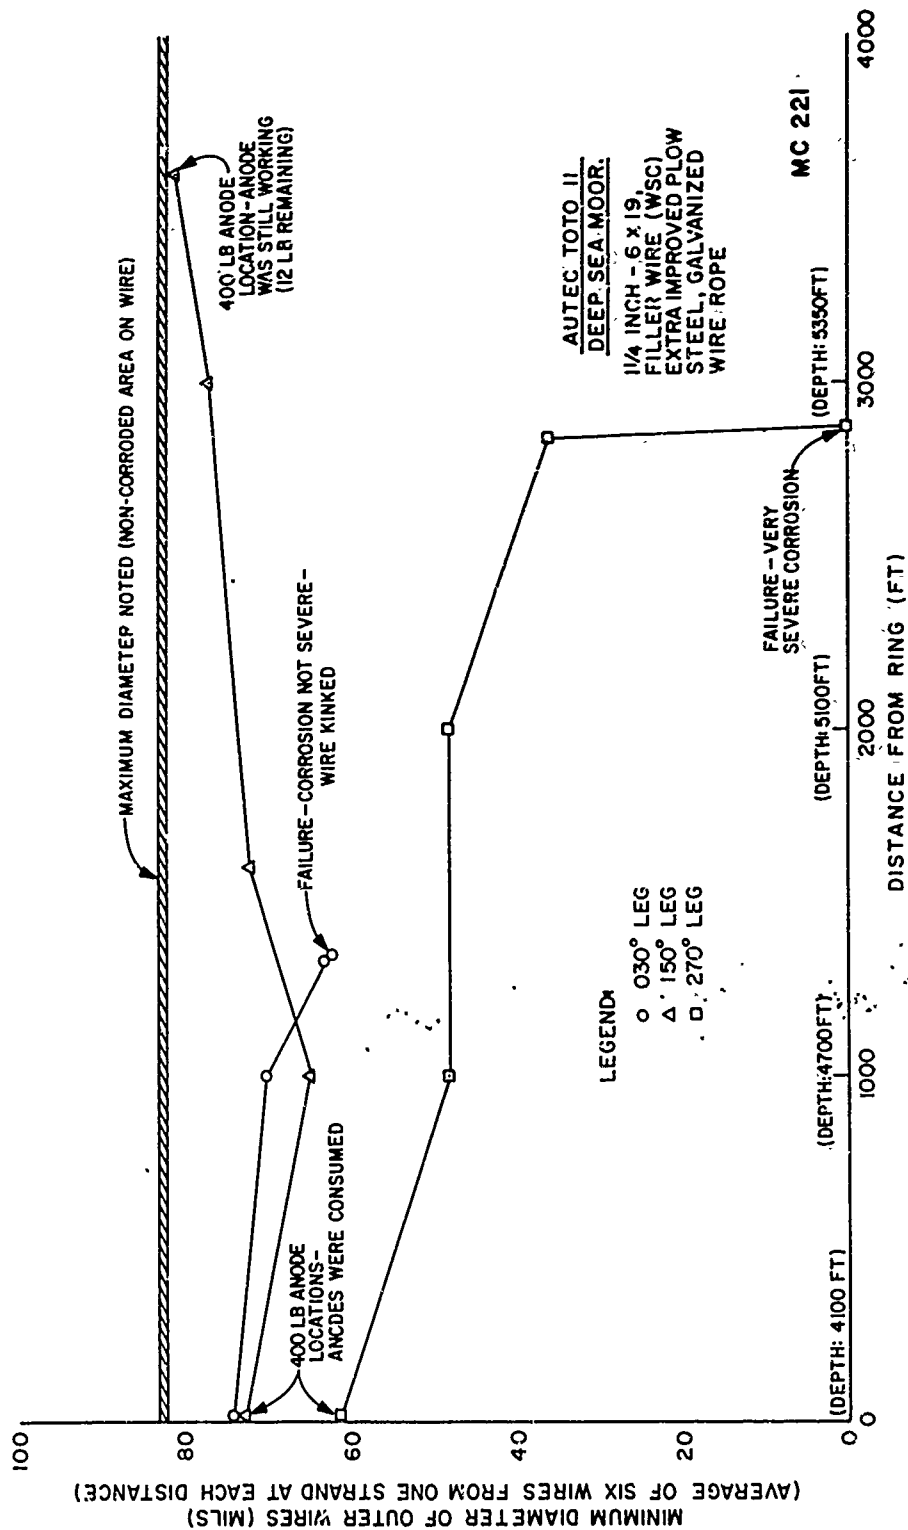
The average minimum diameter of the outer wires of the lower catenary ranged from 0 to 81 mil as shown in Fig. 7. The outer wires from the 270° lower catenary at the point of failure were completely severed by corrosion. Severe corrosion was also noted on the core strand of the 270° lower catenary at this point. Severe reduction of the diameter of the outer wires was not noted on the 030° lower catenary which failed or on the 150° lower catenary. This suggests that the 400-lb anode at the lower end of the 270° lower catenary was lost when the moor was laid and thus permitted severe corrosion to occur. Another significant factor which contributed to the severe corrosion of the 270° lower catenary was the relatively poor coverage of bituminous coating on the strands (Table 2). The appearance of failed ends of wires from the 030° leg lower catenary is shown in Fig. 8.

Fig. 7 - Minimum diameter of outer wires from the lower catenaries. Distances are relative to the ring located about 4100 ft below each intermediate buoy as zero. Approximate depths of water are shown in parentheses.

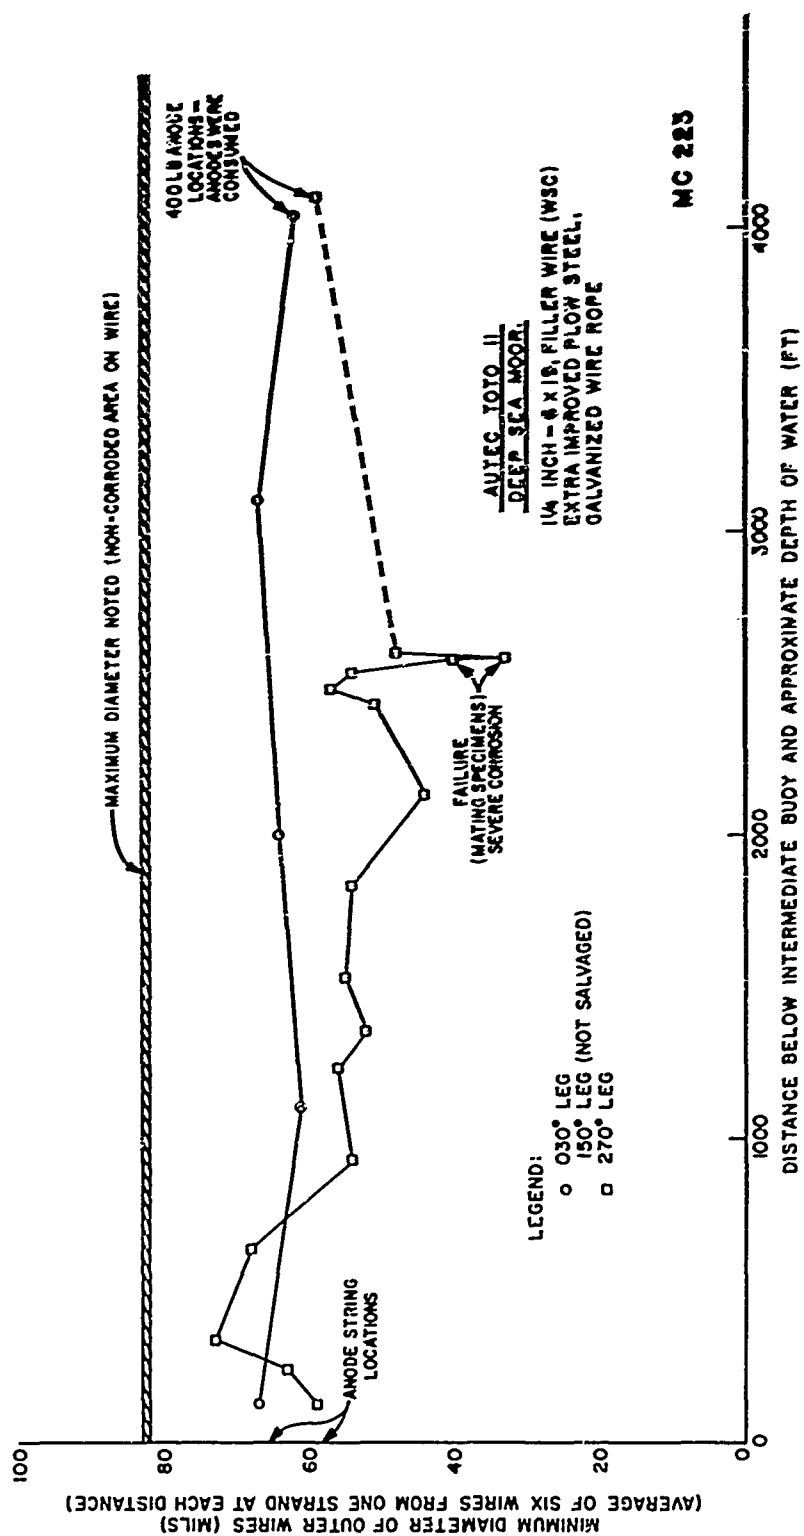
The contrast in performance of the risers beneath the intermediate buoys of the 030° and 270° legs is shown in Fig. 9. Data from the failed 150° leg riser are not shown because samples were not available. It is evident from Fig. 9 that the diameters of outer wires from the 030° leg riser were not drastically reduced, but the opposite effect was noted for the 270° leg riser which failed because of severe corrosion. The only apparent explanation for the divergent behavior of risers is that the 030° leg riser was relatively well protected by the bituminous coating (Table 2). A cross section of the 270° leg riser approximately 50 ft above the failure is shown in Fig. 10, and the appearance of failed ends of wires from this riser is shown in Fig. 11.

Fig. 9 - Minimum diameter of outer wires from the vertical risers beneath the intermediate buoys. Distances are relative to each intermediate buoy as zero.
